EXAMINATION OF WELDED JOINT FROM THE COOLING SYSTEM OF PHOTOVOLTAIC INSTALLATION

Abstract: *The quality of a welded joint in expansion tank of the water cooling system of a photovoltaic installation is identified. A lot of flaws are found after analyzing the macro- and micro structure, and the chemical content of the welded joint. The incorrectly followed mode of welding with high linear energy has resulted in high residual welding stresses, overheating of the metal and continued detention at high temperature. Thus the corrosion resistance of the metal in the heat affected zone (HAZ) decreases and this is the most likely reason for corrosion and cracking.*

The objective of the present study is to determine the quality of the weld joint "longitudinal seam" of an expansion vessel from the water cooling system of photovoltaic installation.

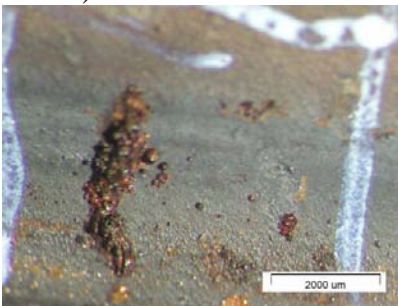
During the visual control of Sample 1, a rupture (defect) is found within the area marked by the client. From the outer side there is a dark trace parallel to the weld at about 3mm distance. The same trace, however much more pronounced, is seen from the inner side too. There is corrosion on the inner side of the weld and the adjoining zone from the side of the welded joint. The flaw is located within the dark trace zone.

Fig. 1a. Flaw on the inner surface, Spec. No1, SM

The defect runs perpendicular to the welded joint and a network of cracks is observed. There are no flaws observed on the surfaces of Specimen No 2.

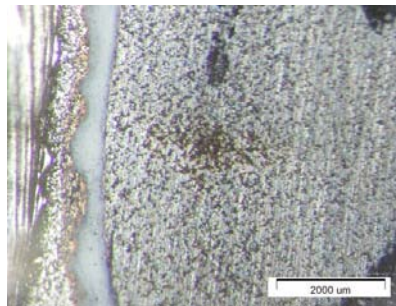
Fig. 1b. Flaw on the outer surface, Spec. No1, SM

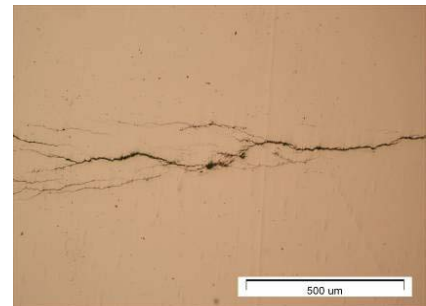
Fig. 1c. Flaw on the outer surface, (after grinding and polishing), Spec. No1, SM

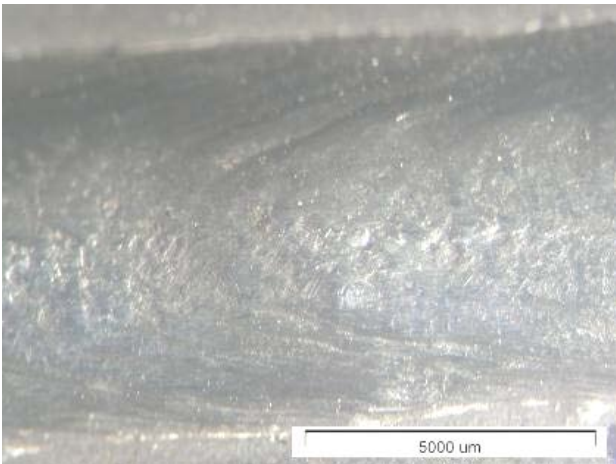
The surfaces of the weld seams are shown in *Fig. 2, a)* and *b)*. There are no flaws found on the surfaces of the weld seams.

Fig. 2a. General view of the welded joint, Spec No1, SM

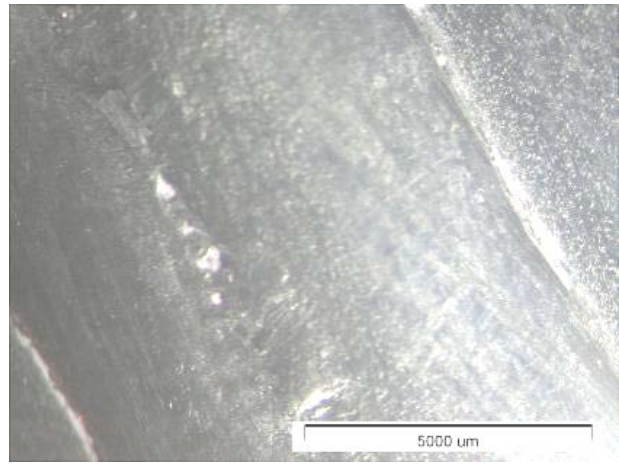
Fig. 2b. General view of the welded joint, Spec No2, SM

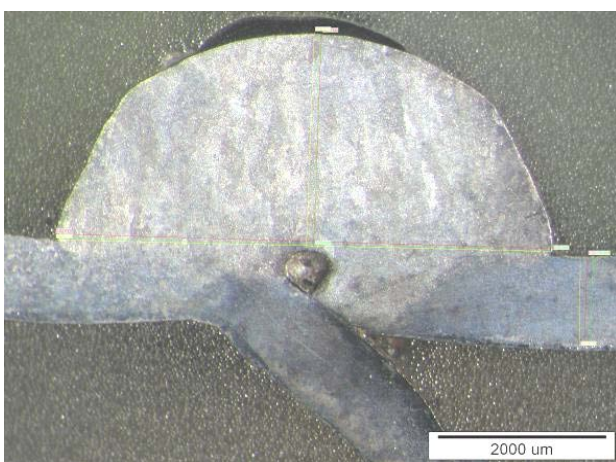
The microstructure of cross-section of the longitudinal weld seam (Sample 1) is shown in *Fig. 3a*. The micro-structure is typical for weld seam metal of austenitic steel containing relatively small amount of ferrite. The cross section of the weld seam metal in Sample 2 (Spec. 2) has considerably smaller dimensions. (*Fig. 3b*). Obviously the seam is made with much lower linear energy of welding and meets the requirements of ISO 5817 (БДС EN 25817).

Furthermore, the dimensions of the cross section of the weld metal in Sample 1 are too large, i.e. 7.90 mm width and 2.59 mm height. For comparison, the thickness of the base metal is 1.02 mm. Also, the weld seam metal has spilled onto the base metal with no weld interfusion between the two metals.

There are flaws observed: a large pore in the middle of the seam (*Fig. 3a*) and lack of interfusion in the transitions from weld seam metal to base metal (*Fig. 4*).

Fig. 3a. Macro structure of Spec. No1, SM.
The dimensions of the weld seam measured from the image are: width $B=7.90+0.02$ mm; height $h=2.59+0.02$ mm. Thickness of the base metal $d=1.02+0.02$ mm

The mode of welding applied during manufacture of the expansion vessel is inappropriate because of the excessive linear power, i.e. the energy input per unit length of the seam. The longitudinal weld seam of Sample 1 (Specimen No1) is qualified as defective since it doesn't meet the requirements of ISO 5817 (БДС EN 25817) for quality level «B» and quality level «C» according to the following indicators:

- Angle of transition from weld seam metal to base metal. For Sample 1 (Specimen No1) it is equal to 90 degree and does not meet the requirements for the lowest quality level «D». This angle shall be more than 150 degree for quality level «B» and more than 100 degree for quality level «C». The reason is the excessive convexity (i.e. height) of the seam;
- Spillage a portion of the seam metal onto the base metal. This is unacceptable for both quality levels «B» and «C».

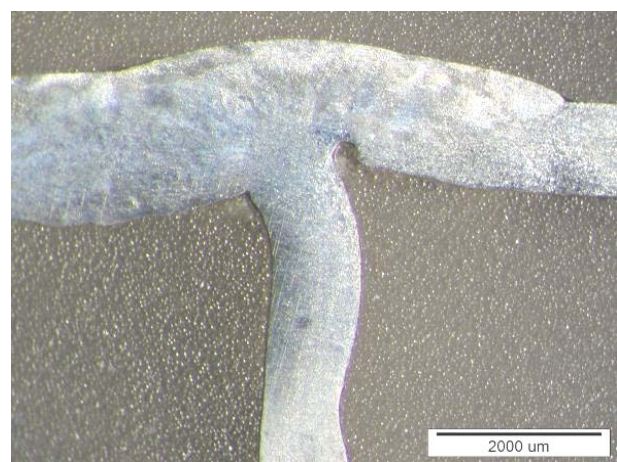
Fig. 3b. Macro structure of Spec. No2, SM.
The dimensions of the weld seam measured from the image are: width $B=5.42+0.03$ mm; height $h=0.63+0.14$ mm. Thickness of the base metal $d=1.04+0.02$ mm

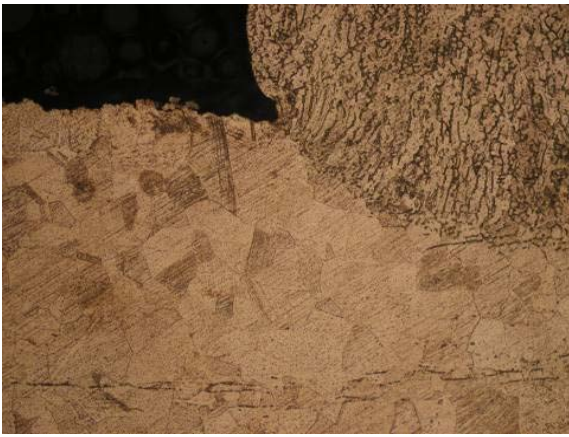
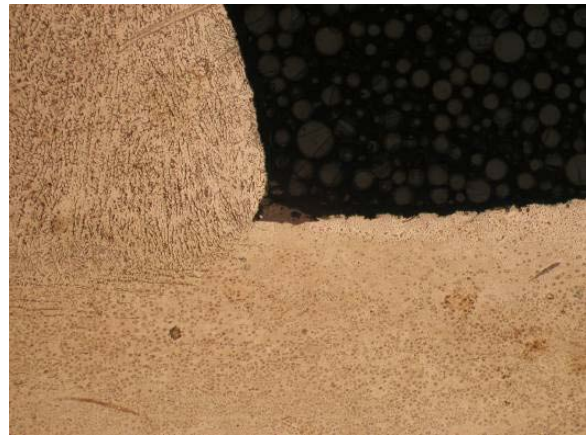
Fig. 4. Flaws in the transitions from weld seam metal to base metal, left and right end of the seam, OM

The expansion vessel Sample 1 is poor quality. A lot of flaws are found therein, e.g. areas with corrosion and numerous cracks. The longitudinal weld seam of the expansion vessel is poor quality too. The sharp transition angles between the weld seam metal and base metal, and the spillage of weld seam metal onto the base metal with lack of interfusion are inadmissible defects.

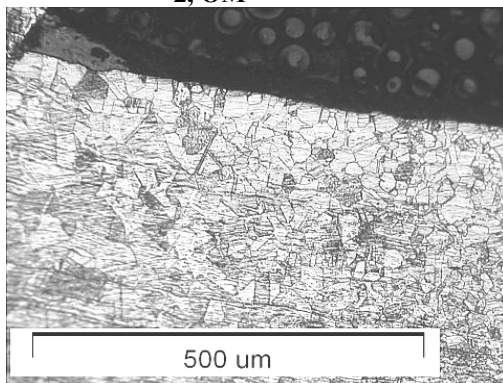
Fig. 5c. Microstructure of HAZ (austenitic structure with deformation strips, thickened boundaries of individual grains), Spec. No1, OM

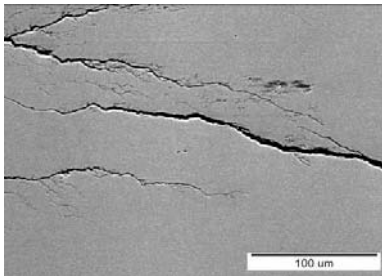
The examinations using Scanning Electron Microscopy (SEM) and Electron Probe Micro-analysis (EPMA) are carried out. The images of the micro-structure of cross sections of the weld seams in secondary electron mode are shown in (*Fig. 6*). The inter-crystal cracking (the defect on the outer surface of the vessel), as well as the variation of chrome content within the cracking zone are shown in *Fig. 7*.

Fig. 7a. Inter-crystal cracking (flaw on the outer surface), Spec. No1, SEM

There are distinct areas of inter-crystal corrosion observed in Sample 1 (Specimen No1), as well as numerous inter-crystal cracks that are unacceptable flaws.

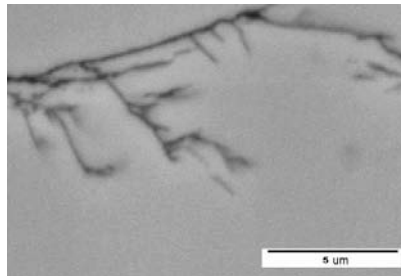
Fig. 7b. Inter-crystal cracking in the area where the variation of chrome content is examined, Spec. No1, SEM

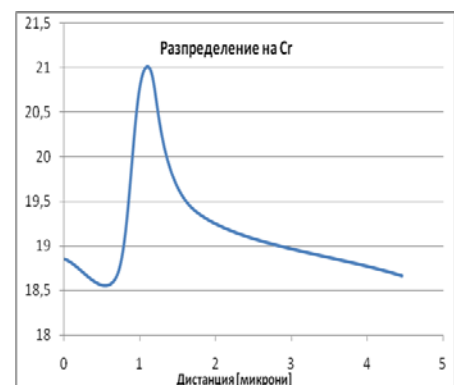
Fig. 7c. Variation of chrome content within the zone of inter-crystal cracking, PMA

the diffusion processes that leads to re-distribution of the alloying elements and especially chrome, as well as to formation of chrome carbides. Thus the chrome content in localized areas decreases which leads to decreased corrosion resistance of steel in the HAZ.

The most probable reason for occurrence of corrosion and cracks in Sample 1 (Specimen No1) is the inappropriately chosen mode of welding with high linear energy. It has lead to occurrence of high residual stresses in the HAZ, as well as to overheating and continued detention of the HAZ metal at higher temperature. All abovementioned circumstances lead to a lower corrosion resistance of the HAZ metal and initiation and development of cracks.
