## **DEVELOPMENT OF WIRELESS SYSTEM FOR TEMPERATURE MEASURING IN AXLE-BEARINGS OF RAILWAY VEHICLES**

**Dragan Petrović, Milan Bižić**

**Key words:** *Temperature Measuring, Axle-bearings, Railway Vehicles*

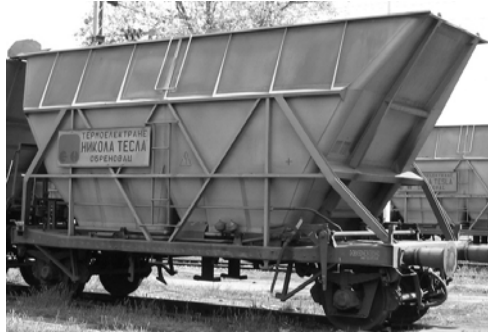
**Fig. 1. Fbd wagon for transporting coal**

Interest in the problem of derailment of wagons due to overheating of axle-bearings arose at the request of the thermal power plant "Nikola Tesla" (TENT) from Obrenovac, Serbia. Namely, coal is transported from the mines to the thermal power plant by rail. The Fbd wagons are used for this transport, which are composed of two 2-axle units that are rigidly connected to each other (Fig. 1).

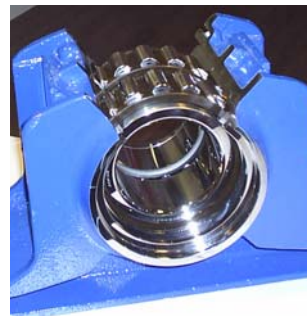
**Fig. 3. Bearings of railway vehicles**

The coal transportation process is extremely intensive and annually in TENT Obrenovac amounts to about 25 million tons. In the process of exploitation of railway vehicles, axle-bearings are among the most loaded elements (Figures 2 and 3). Their correctness and reliability directly affect the correctness and reliability of the entire train. The failure of the axle-bearing in a large number of cases causes the train derailment (Fig. 4), which is accompanied by enormous material damage, and often with human casualties.

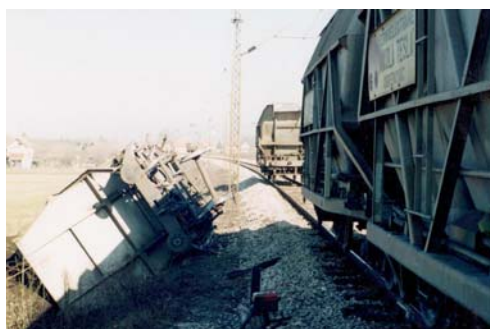
**Fig. 4. Derailment of wagons for coal transportation**

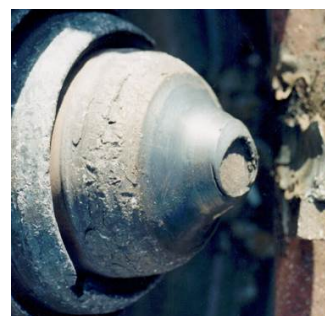
**Fig. 5. Failure of axle-bearing**

By analyzing the accidents of freight wagons in TENT Obrenovac, it is founded that the most often there is an increase in the axle-bearing temperature, as a result of which the axle journal softens, and it can be broken (Fig. 5). Failure of the axle journal causes the derailment of railway vehicle, so special attention was paid to this problem.

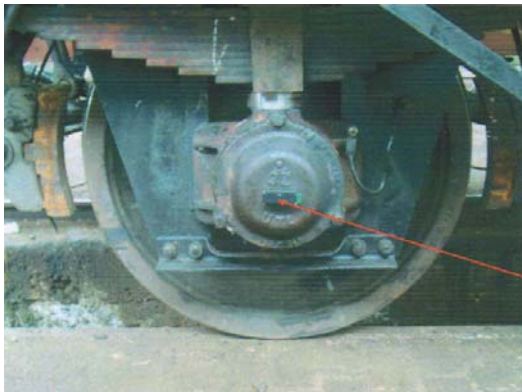
Fig. 9. Testing of transmitting sensor unit on axle-box bearing

Static testing of the system for continuously measuring the temperature of the heating of axle-bearings was carried out on wagons of the Wagon Factory Kraljevo, as shown in Figures 9 and 10. The sensor unit was placed on the bearing cover, and the axle assembly housing was heated by artificial means. The functionality and accuracy of the system were demonstrated and tests of the functioning of the constituent components were performed. It has been confirmed that the system is conceptually very well structured and that, after tests on the composition in motion, it can enter mass application on industrial and commercial railway lines.
